P DETROIT PUMP

Customer Spotlight Case Study Solving the Liquid Glass Diaphragm

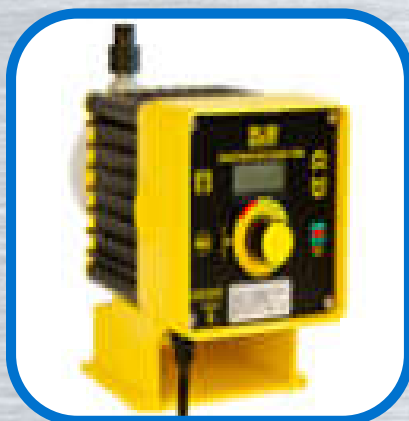
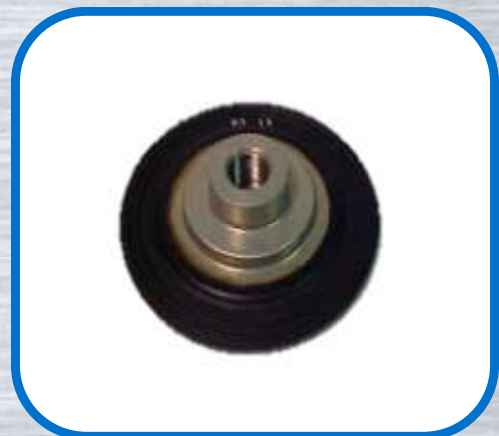
Improved Design

The Problem: Pumping sodium silicate was destroying diaphragms, on average just lasting 8-10 weeks. The failures were leading to down time, high maintenance costs. After researching the issue, the problem was the sodium silicate, when exposed to air prematurely hardened into “liquid glass”. These particles would they etch the Teflon overlay of the standard diaphragm leading to the early failures.

- * New design specifically for customer situation
- * Reduced maintenance
- * Reduced downtime from failures

The Solution: Detroit Pump and LMI designed a new diaphragm for the customer. The Teflon overlay was removed, the materials were changed and reinforced the diaphragm. With the new diaphragms installed, the user has not experienced a diaphragm failure in over two years.
